CAMS

APPROVED VEHICLE SPECIFICATION

Make of Car: Volkswagen

Model: 1200 Sedan
(Type 112/114)

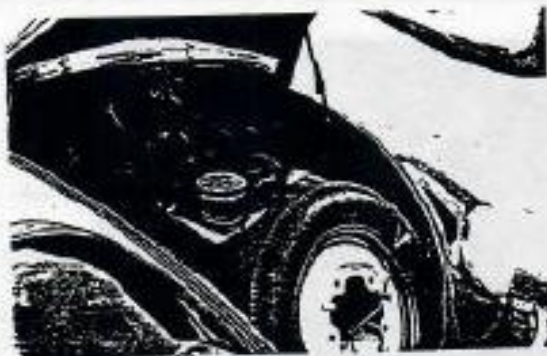
Together with its equivalent on the engine lid, the clamping strip retaining the rubber seal on top of the inner wing, seen on a 1947 car (above left), is the only part of the Beetle that remained unchanged throughout European production. Problems with originality frequently occur in the Beetle world. This is a genuine oval window from a 1953 car (below left), but some 1950s owners of earlier split-window cars upgraded them to look more modern.

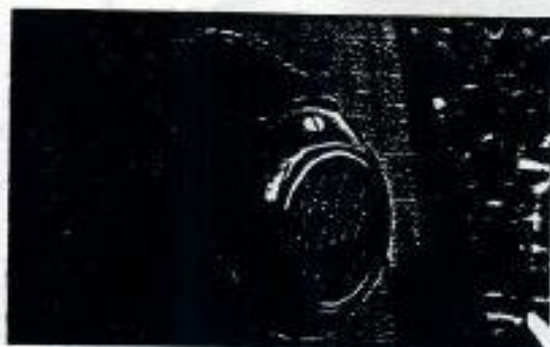
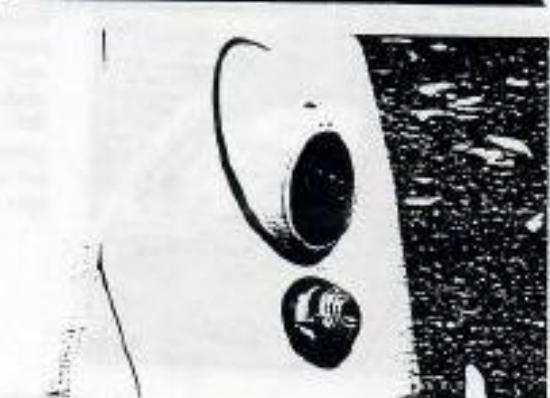
With earlier Beetles, there are instances where enthusiasts have to ask themselves whether originality is more important than safety. Whereas the owner of this 1953 car (above right) has not altered the skywards-pointing brake lights, the owner of this 1957 model (below right) has chosen to add modern flashing indicators to supplement the normal semaphore.

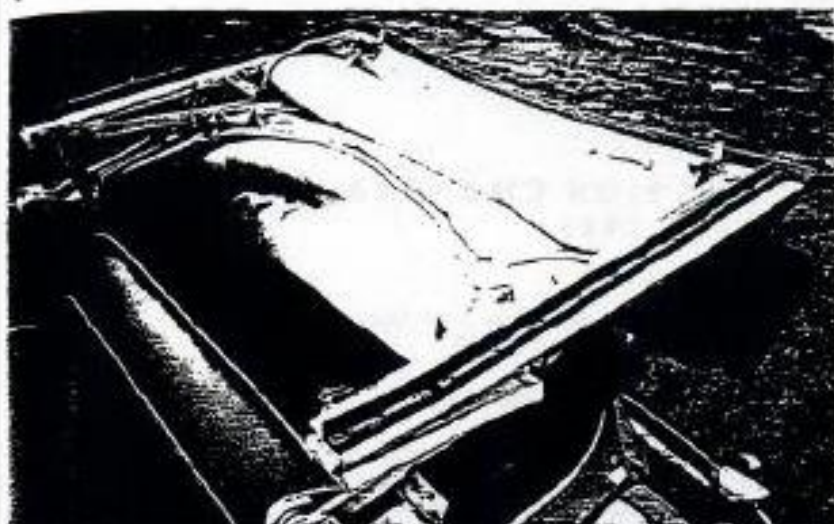
For the greater part of the initial production life, the wood () was made with a heavy plastic headlining and a heavy leather and rubber filling. Enlarged heater vents (right) with bright metal surrounds and wire gauze covers appeared in 1954, while the clutch and brake pedal covers displayed the VW logo. The roller ball clutch pedal persisted on until a more conventional flat pedal replaced it for the 1958 model year.

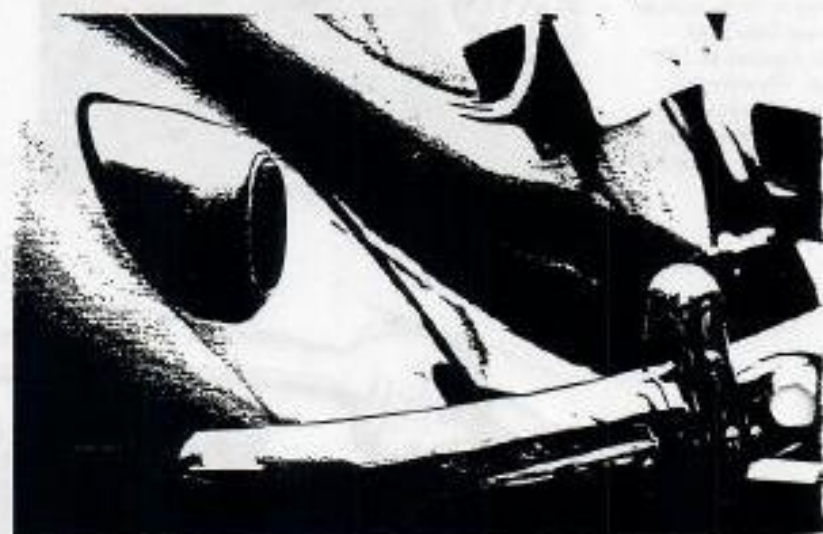
The V-worm-II emblem in the centre of the hub caps (left) was sometimes highlighted in a colour until September 1956, but black was always used by the factory thereafter.

There were no bodywork modifications as such, but the cabriolet's steel hood studs were replaced by corrosion-resistant brass items. From early September, the VW emblem in the centre of the hubcaps is always highlighted in black, whereas previously a variety of colours had been available. Considered by something rather special at the time, an experimental batch of 800 cars built in June were fitted with 5.00-15 tubeless tyres, which became standard on 10 July. It would be another four years before the English rally driver, Bill Bengry, had the opportunity to go rallying in a Beetle fitted with Pirelli Cintaradials for the first time. In March, the ground clearance of the Export model was reduced from 172mm to 155mm.

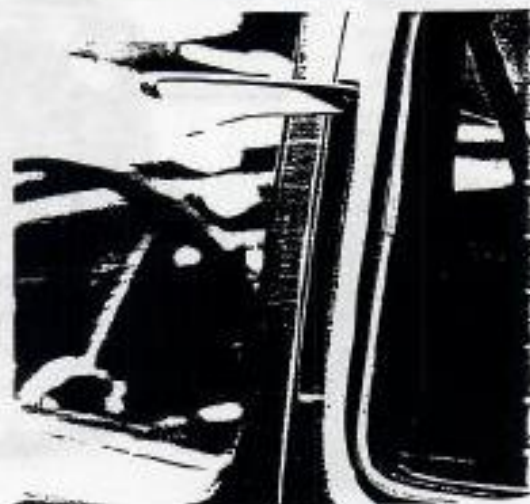
While European and British cars introduced in 1960 with non-illumination indicators (right), Beetles exported to North America gained more modern (and necessary) lighting indicators from 1955.

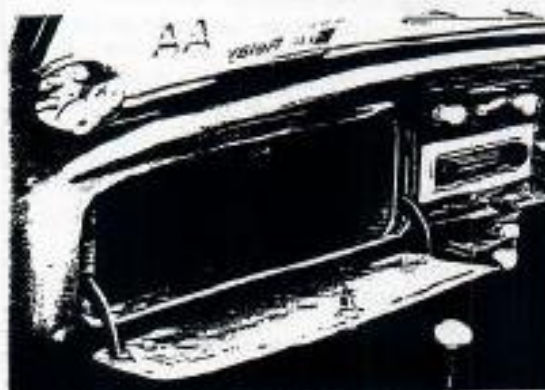
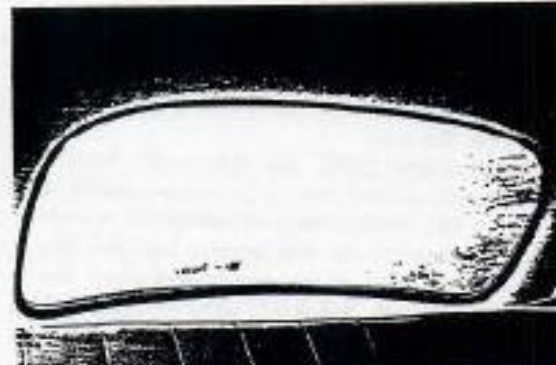
The windscreen was enlarged (far left) by pulling down the A-post and making the roof flatter at the front. Because the rear window had also been enlarged, the rear view mirror was increased in size. The increased size of the rear window (left) made the cabin brighter, and therefore a little less cosy.

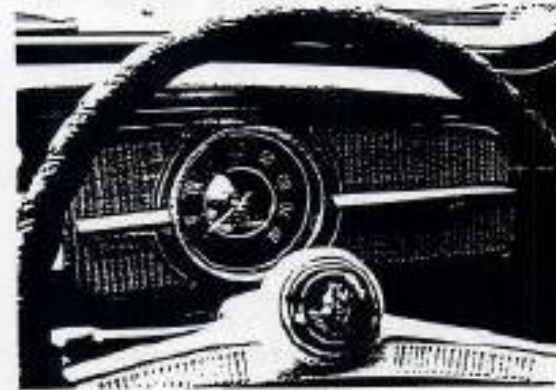
The glovebox was enlarged considerably (far left), the light and windscreen wiper switches were better spaced, and the ashtray, which always makes a terrible scraping noise, was placed below the radio. For the first time since October 1952, the dashboard was completely modified (left). The radio speaker grilles were placed either side of the speedometer and, except on the standard model, higher than in the model.

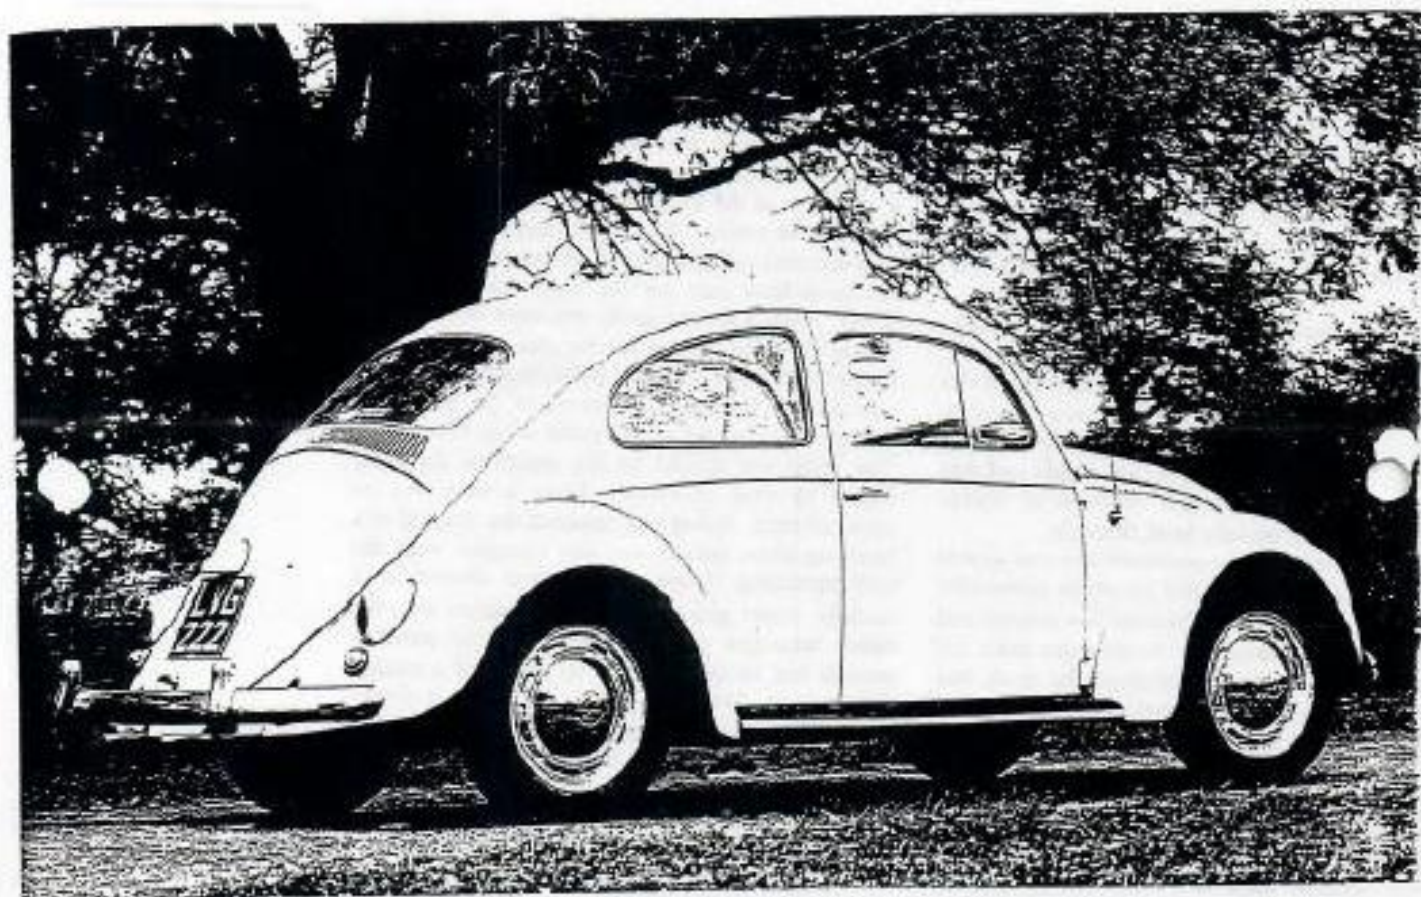
The 1958 model year saw the arrival of the first of the 'big window' cars, a move which brought the Beetle into its 4th age. But its 1000 indicators were retained, which is why this regularly-used car - from a year in which survivors are surprisingly rare - has been repaired by owner Eino Miller with 'bolt-on' flashers. To accommodate the larger glass, the air horns were shortened and the engine lid was modified.

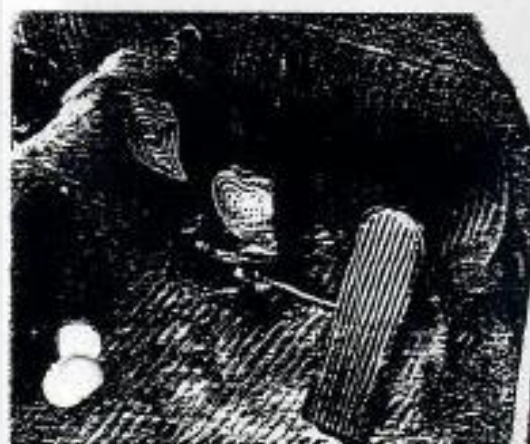
Among detail changes on the 'big-window' Beetle, the roller ball throttle pedal was at long last replaced by a more conventional flat pedal.

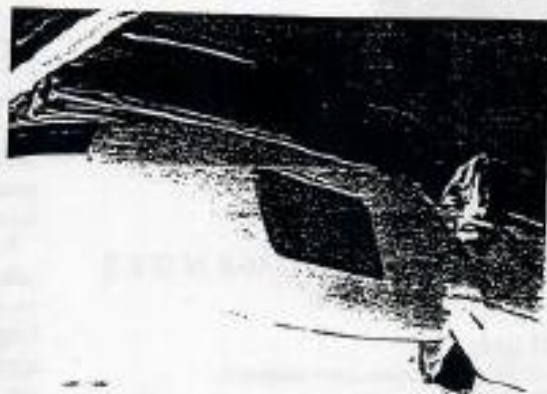
The dashboard fabric was unchanged, but the four-spoke steering wheel was redesigned and a semi-circular horn ring was introduced.

Instead of the earlier pull-out style, the new 'safety' door handle star lifts were fixed in position and operated by pressing the rectangular button. A photostatic sun visor light replaced the attractive tinted perspex lens.

The Export model's steering wheel received a redesign: although the hub retained its attractive Wolfsburg crest, the two spokes were much more deeply dished and a semi-circular ring was added for operating the horn. Over the years, these horn rings have demonstrated a propensity for snapping (usually when you are not looking so that everyone who has been near the car in the past 10 years is suspected), but they can easily be replaced, or repaired and rechromed, if necessary.

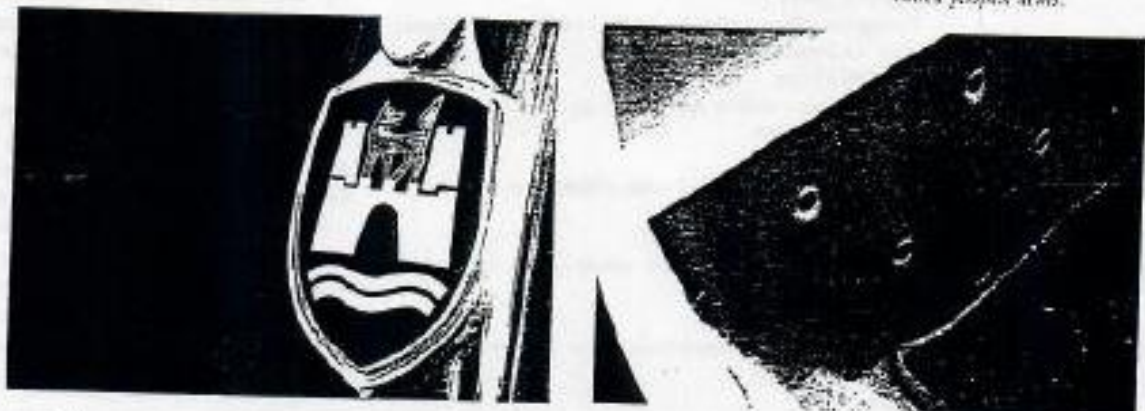
From August 1959, the wing-mounted Wolfsburg logo was simplified and became less colourful. In an effort to reduce wind levels in the cabin, leaf boards were installed below the rear seat. A rubber and leather felt is applied to the two halves of the floorpan.

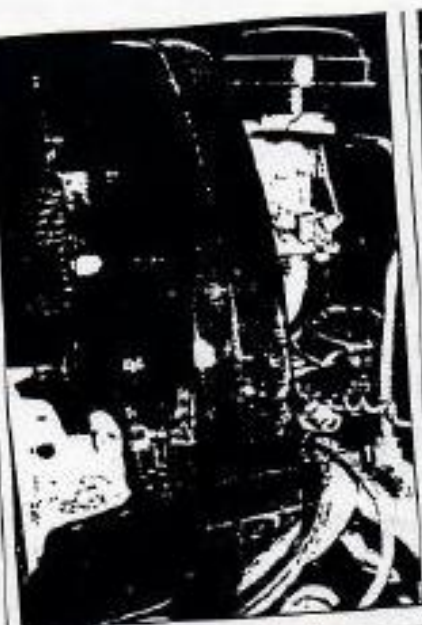
ABOVE, early manual cooling fan regulator was changed to fully automatic system in 1950. RIGHT, center-seamed fan housing is a real collector's piece, and was replaced in mid-1952 with the modern seamless unit which was spot-welded together on recess along front edge.

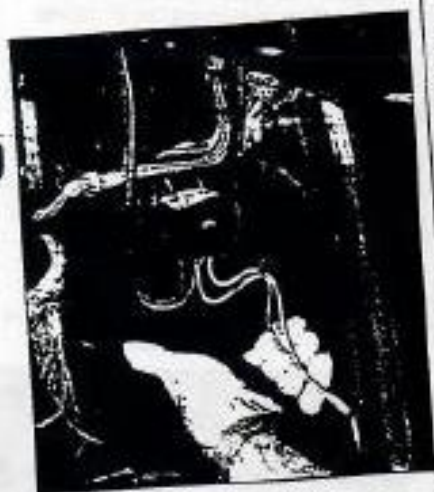
ABOVE, 1950 engine was first to have larger "coffee can" air filter, as well as aluminum "hot spot" on intake manifold to aid fuel atomization. BELOW, interestingly enough, the identification label on the coil was purposely installed upside down so it could be easily read while standing on the dealer's shelf!

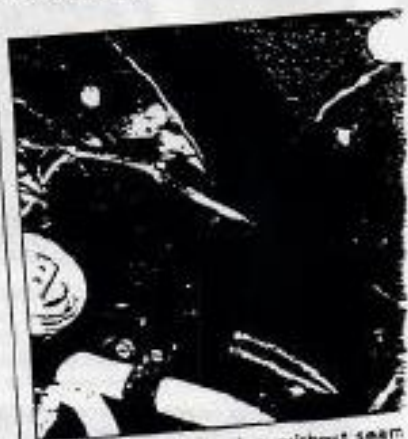
Later 36hp fan housing. Without seam. Metal plug wire tubes were used to

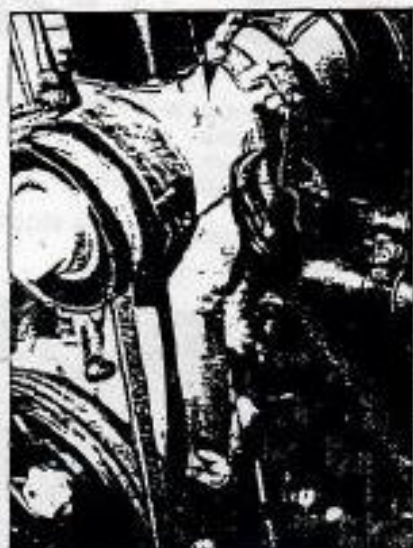
ABOVE, manifold hot coat was introduced in '50, moved to down pipe right below carb in '54 and returned to horizontal in '55. BELOW, oil filler with separate cap was introduced in '56.

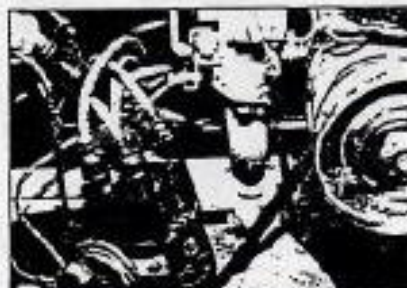
ABOVE, early (to '55) oil filler pipe was secured by a clip. Large hold-down nut on generator pulley was used until '56. BELOW, this 1960 engine looks much like the one we're familiar with today.

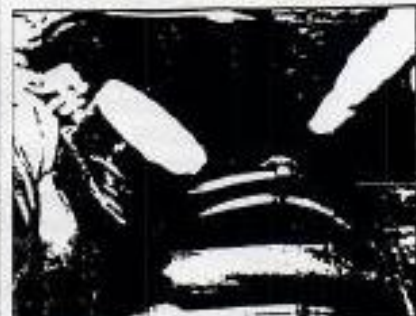
LEFT, oil bath air cleaner became standard in '54. Early units only had one clip; two-clip version was mid-'55 update. ABOVE, metal wire tubes were replaced with these rubber support grommets in '59, for radio noise suppression.
