5TH CATEGORY - HISTORIC RACING

APPROVED VEHICLE SPECIFICATION

FORD

Model: ESCORT TWIN-CAM

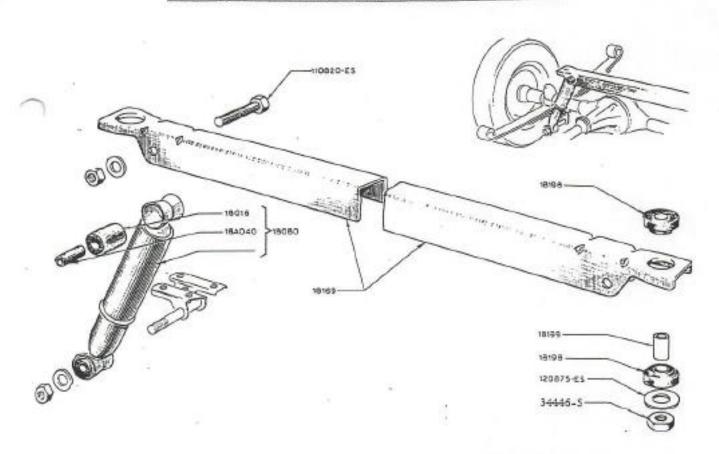
DETAIL OF REAR SHOCK ABSORBER MOUNTING

ALL GROUP No Mk.I ESCORTS INCLUDING TWIN-CAM

- 9. Note that prior to 1974 all Mk I Escorts including the Twin-Cam had the upper mounting of the rear shock absorbers in the form of a pressed steel 'U' bracket about 2 feet long bolted to the floor pan. Late model Mk I Escorts had rear shock absorber upper mountings on the floor pan with upper bushes, washers and nuts visible in the boot – this arrangement as well as 'Turreted' upper rear shock absorber mountings (as found on some Mk II Escorts) are not eligible as they post-date the Group Nc termination date of 31 December 1972.

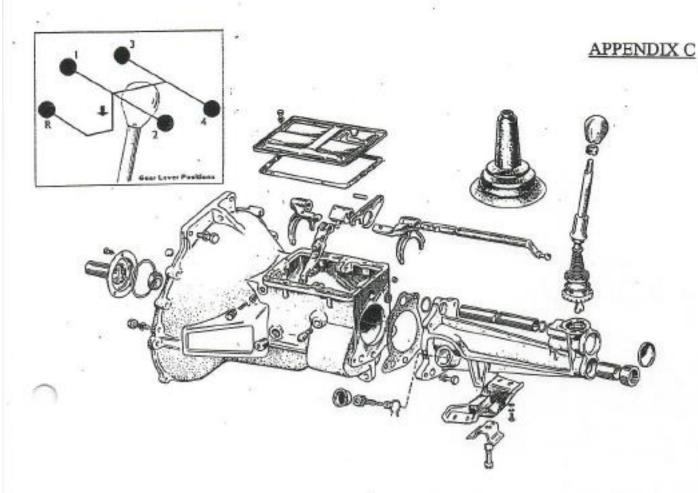
ESCORT MK I Gearbox - note integral bell-housing and case of cast iron. Extension housing is aluminium with gearshift which gives trouble in service.

- 7. As mentioned earlier, the Twin-Cam was fitted with the 2000E gearbox (also found in the Mk II Cortina GT) which has a separate cast iron bell-housing, and the extension housing also of cast iron contains both the output shaft and the remote gearshift linkage in the single housing. Reverse is next to top gear. 'Other' Escorts have an integral bell-housing and gearbox casing of cast iron, with an aluminium output housing in which the output shaft and gearshift linkage are accommodated in separate housings of the single casting. Reverse is next to first gear and the gearshift features a nylon threaded member screwed into the aluminium which is of poor durability and gives frequent problems in service. The two gearboxes are illustrated in the Attachment.

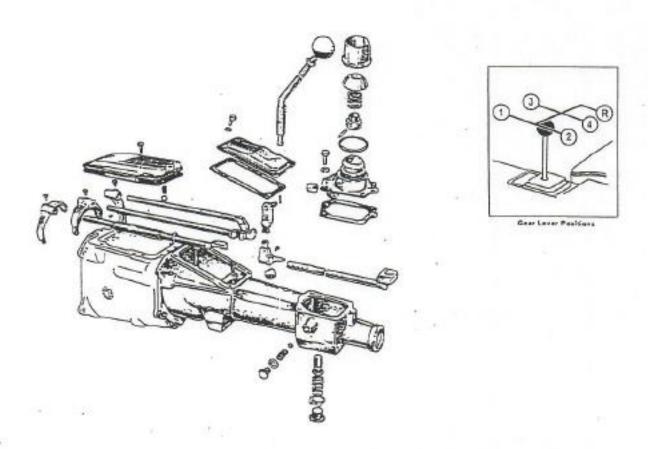
ESCORT T/C Gearbox - bell-housing is separate and both case and extension housing are cast iron.

- 2 The gearbox is the 2000E type (refer Attachment) taken from the Cortina MkII GT. The bell housing has the starter motor on the driver's side (opposite to other Escorts) whilst the clutch slave cylinder is on the left.

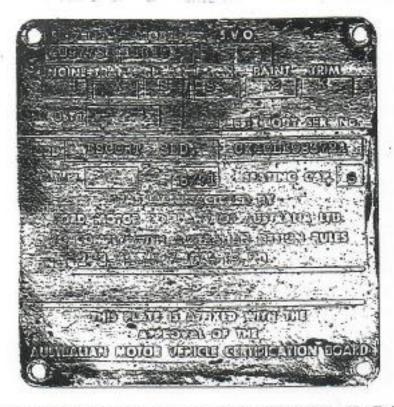
May 1971 production plate which uses "Escort Sed." to describe car. "CK49L" identifies Twin-Cam body shell with "Model 11019" confirming same but "0" indicates 1970 body style having decorative strips only on roof gutters; no decorative strips around side windows.

The body coding detailed above will appear on the compliance plate, together with the date of manufacture - 8/71 meaning August 1971. Ford appear to have been rather sloppy in naming the car - I have noted compliance plates carrying "ESCORT T/C" whilst others (on Twin-Cams) have carried "ESCORT SEDAN". The positive identification of a genuine Twin-Cam body is provided by body serial number prefix which is

CK49K (1970) CK49L (1971) CK49M (1972)
